TECHNICAL BULLETIN

TB-041 • March 2010

6000/7000/7000CC Series No-Slack® Drop Handle

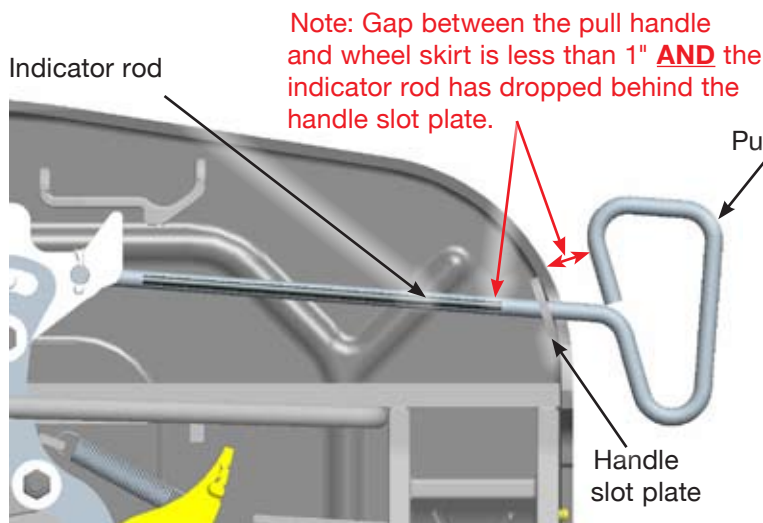
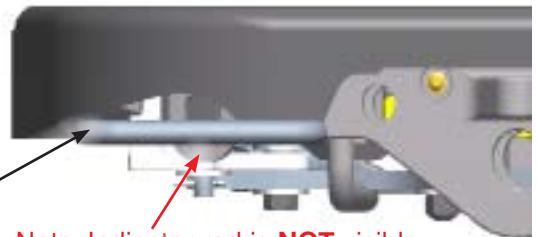
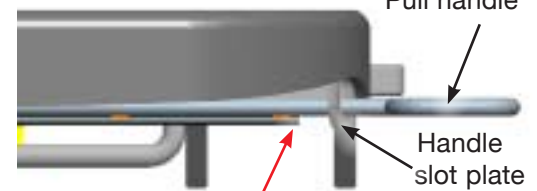
Fifth wheel closed properly

Note: Indicator rod has dropped behind the handle slot plate

This bulletin covers the proper inspection of the No-Slack drop handle. This inspection must be completed after coupling to ensure the fifth wheel is closed. Refer to the illustrations below for details.

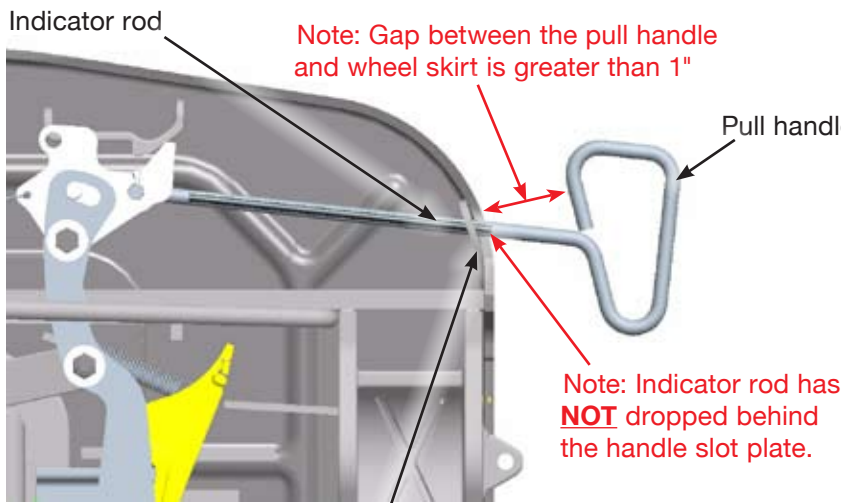
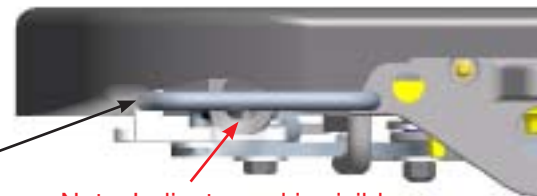
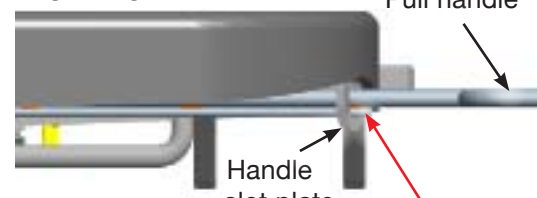
Fifth wheel not closed properly

Note: Indicator rod has **NOT** dropped behind the handle slot plate
